## COMMERCIAL WINDSTORM MITIGATION REPORT (OIR-B1-1802)

Windrush Bay Condominium Association, Inc.

421-428 Windrush Bay Dr, Building D

As of 2/13/2020

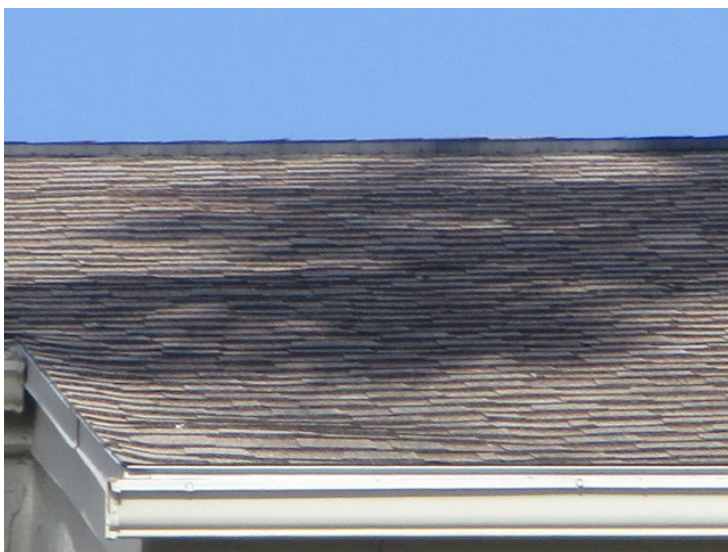
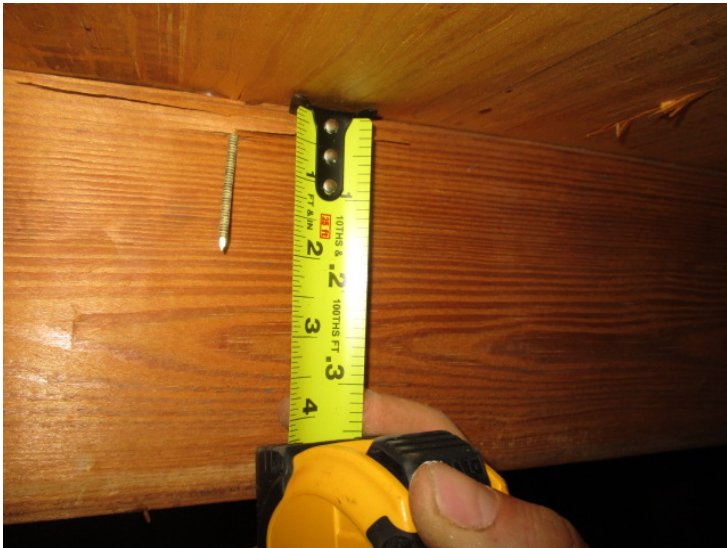
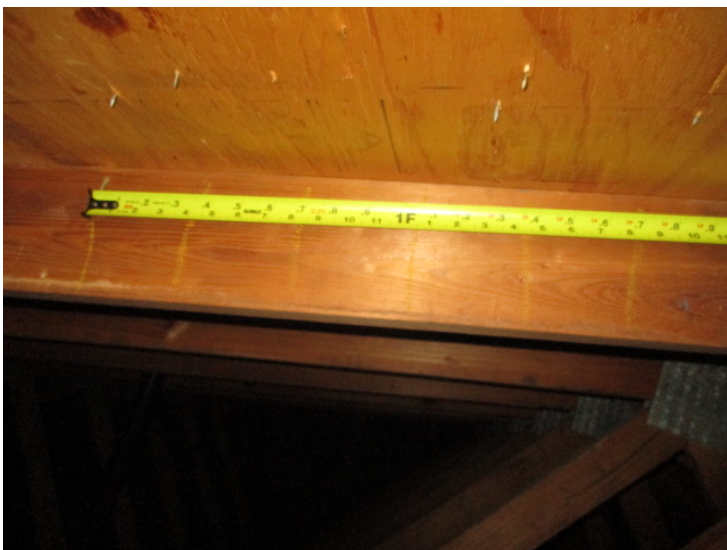
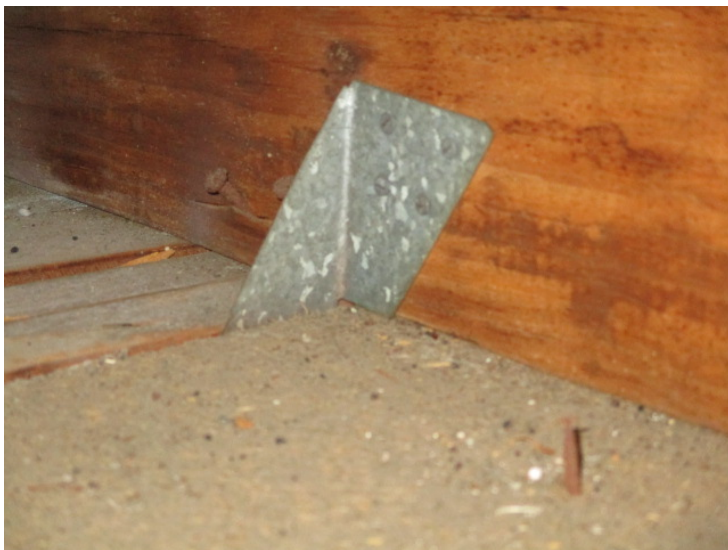
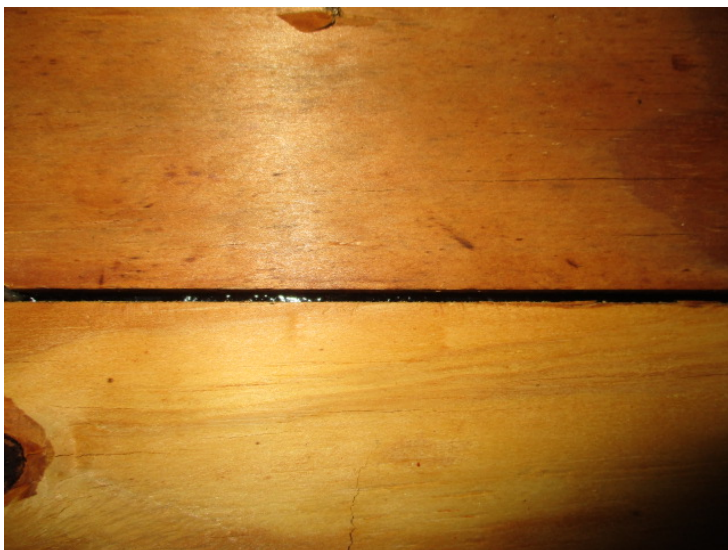
Roof Construction

| <b>3. <u>Roof Deck Attachment:</u></b><br>Comments: | <b>Level C</b><br>Inspection verified 1/2" plywood roof deck attached with 8d nails at a minimum 6" on the edge & 6" in the field. |
| <b>4. <u>Roof to Wall Attachment:</u></b><br>Comments: | <b>Clips</b><br>Inspection verified hurricane clips fastened with a minimum of three nails. |
| <b>6. <u>SWR:</u></b><br>Comments: | <b>Yes</b><br>SWR was verified at time of inspection. The Secondary Water Resistance verified is a self-adhering peel and stick. |
