Windrush Bay Condos Wind Mitigation 617-620

Wind Mitigation Inspection Report

By: Fair Wind Inspections Inc.

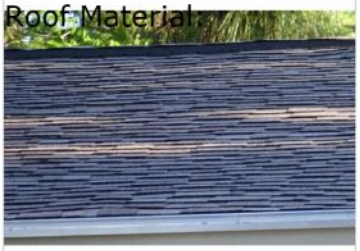
Roof Material:

Date Replaced:	March 18, 2021
Permit With:	City of Tarpon Springs
Permit Number:	21-620
Covering:	Shingles

Roof surface is in good condition
